**FIVE-YEAR REVIEW
FINAL REPORT**

**LEES LANE LANDFILL SITE
LOUISVILLE, JEFFERSON COUNTY, KENTUCKY**

June 1998

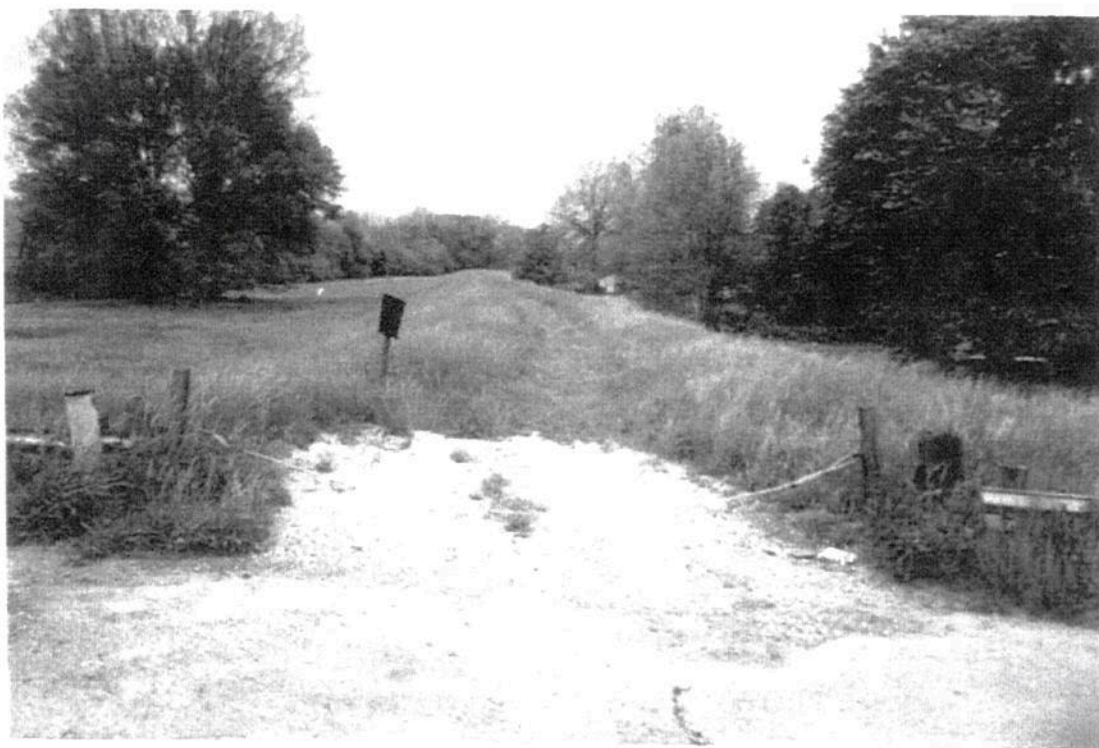
Two other gates are present at the entrances to the floodwall. A southern gate consisting of two square panels was found to be in good condition but unlocked. A cable gate at the northern entrance to the floodwall was locked but was lying very close to the ground surface. Photographs 1 and 2 in Appendix D show these two gates.

Photograph 1: Northeast view of cable gate and floodwall at main entrance to landfill. Note that the cable is very close to the ground surface.

Currently, the gates and barriers to the site will prevent all traffic operating on the roadways from gaining access to the site. The lock on the front entrance gate at Lees Lane must be maintained in order to establish control over vehicle traffic on the landfill. The gates to the floodwall at Lees Lane should have locks restored and the gates improved so that access will be limited. The lack of fencing between the site and adjacent residential property, however, will create difficulty in establishing control over vehicle traffic on the property. Recommendations similar to this for restricting vehicular traffic and maintaining barricades were made in the 1993 RAI report.

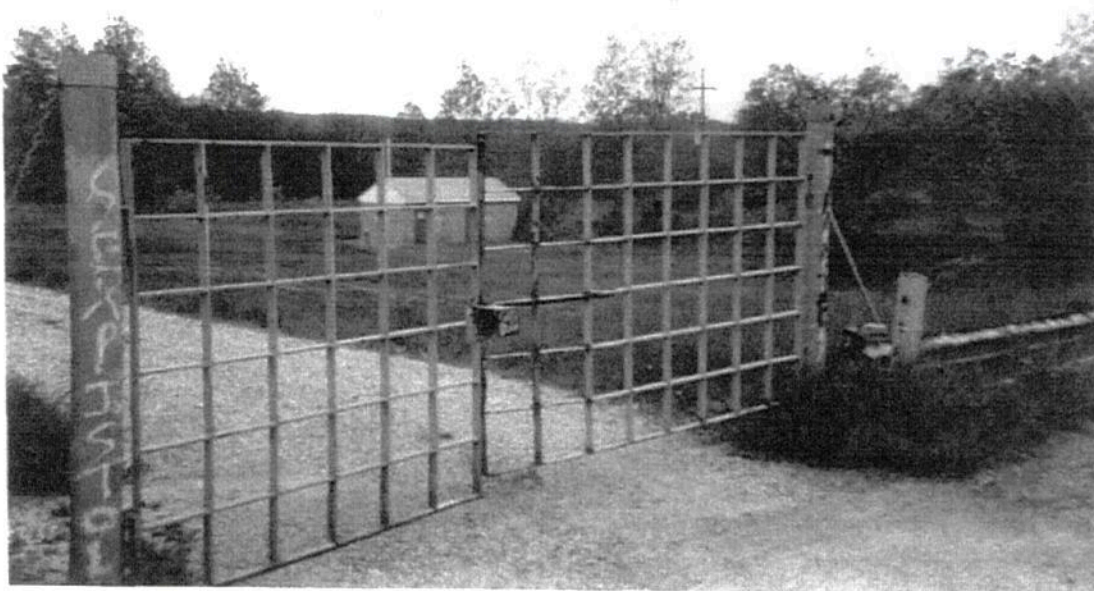
Photograph 2: Western view of gate at main entrance to landfill. This gate is entrance to southwestern portion of landfill and floodwall. Blower house in background.

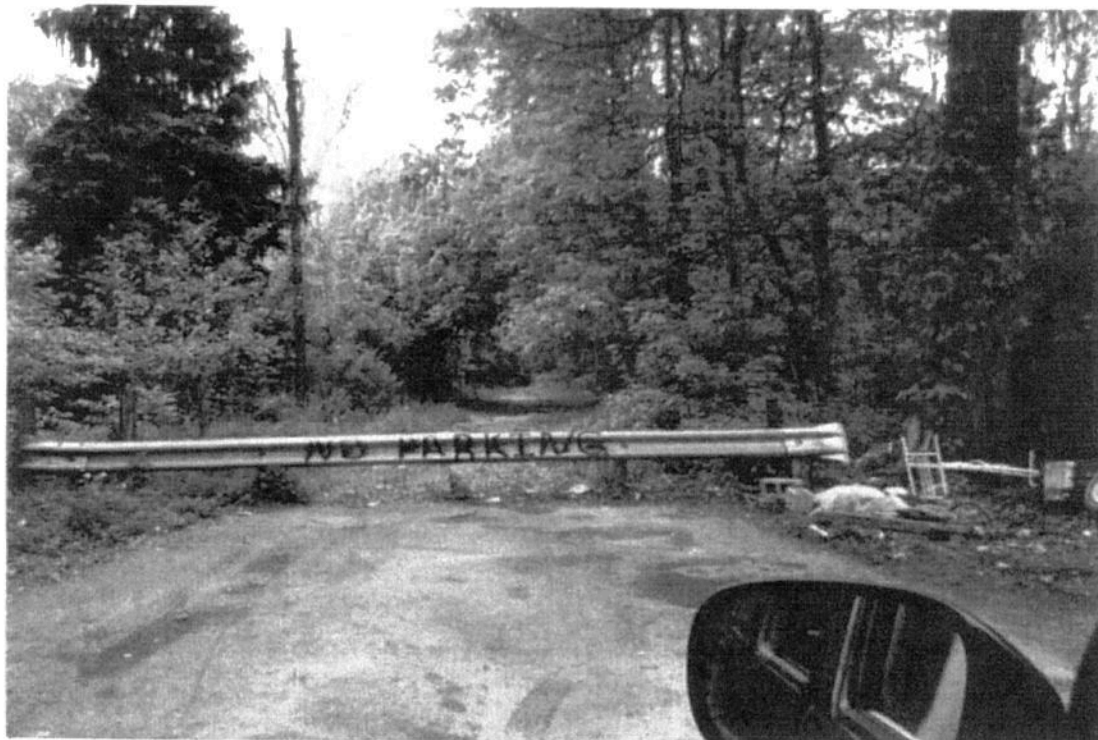
Photograph 3: Barrier across former Putnam Street entrance to landfill. View to the southwest.

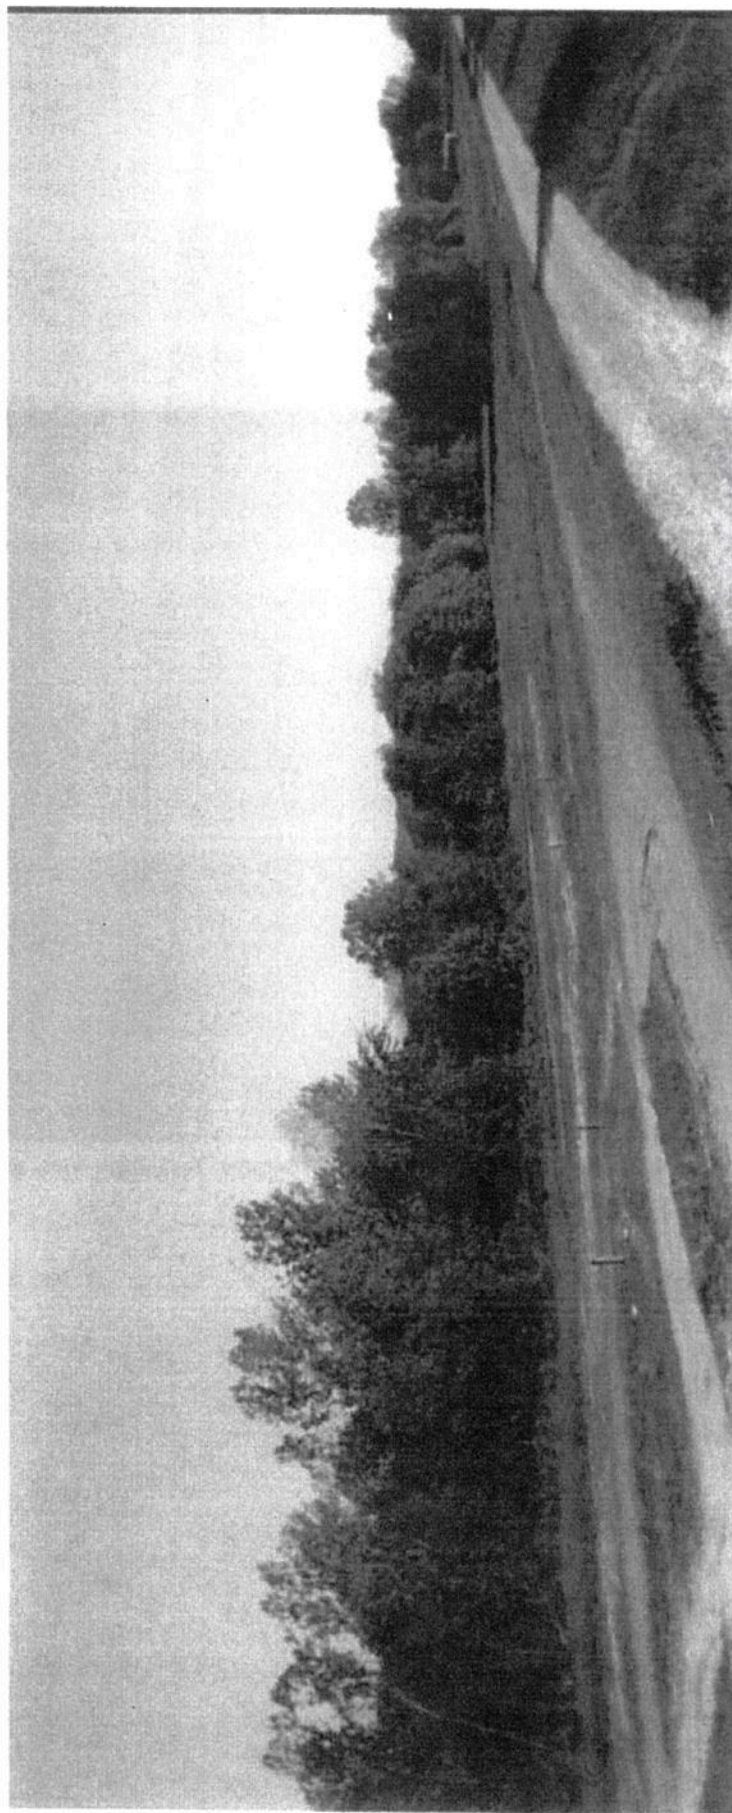
Photograph 4: View of gas collection system along central tract of landfill from former Putnam Street entrance to landfill. View to the north. Blower house in extreme right portion of picture. Note ATV track in foreground of picture. Gravel road is road along top of floodwall.

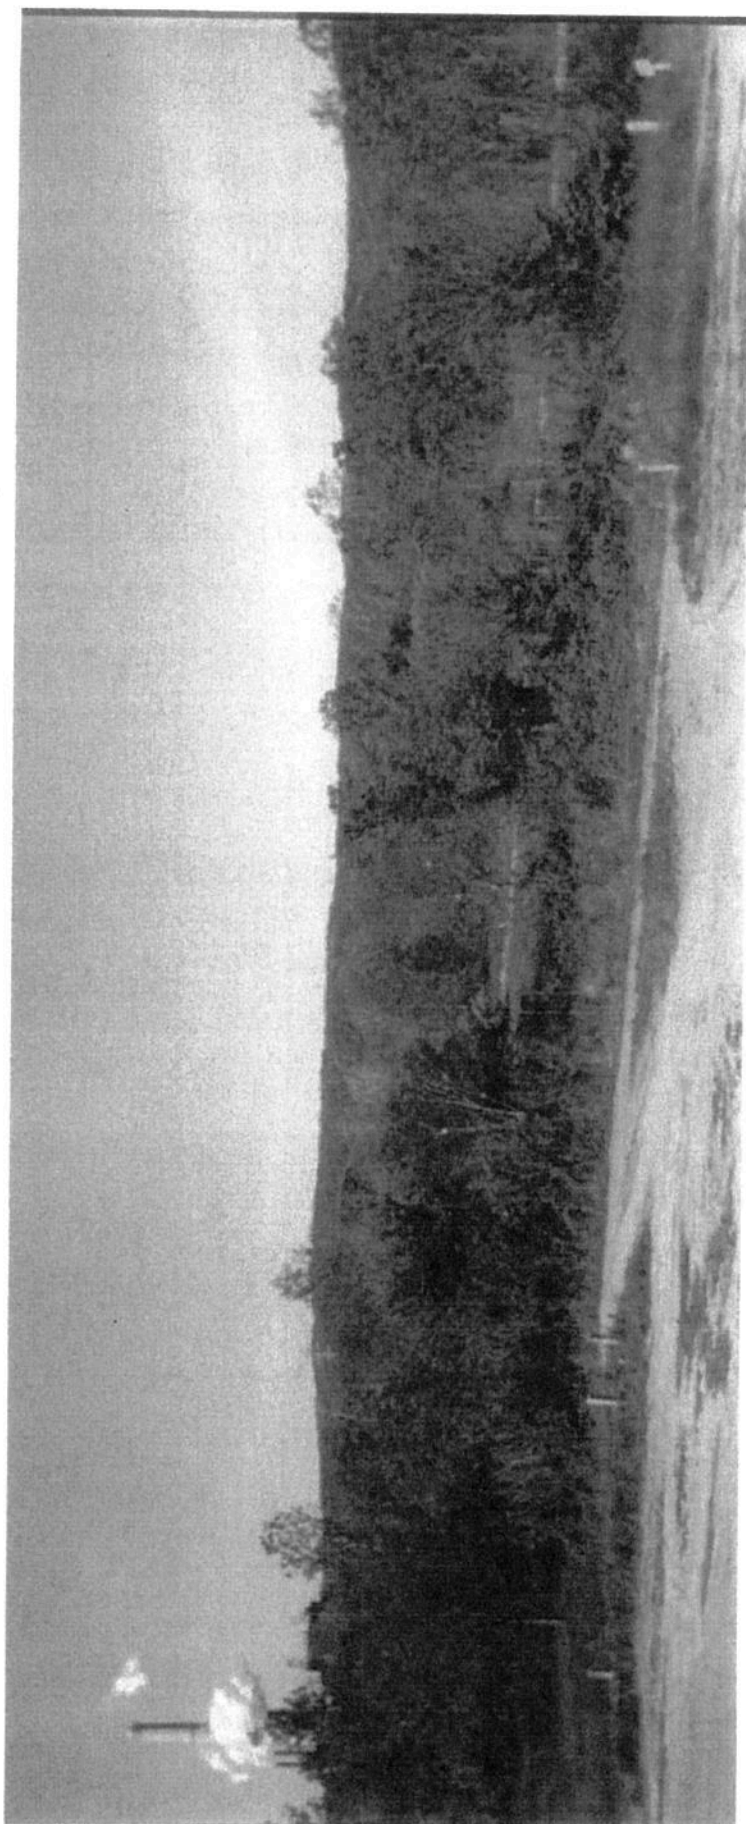
Photograph 5: Western view of southern tract of landfill area. Orange protective barriers represent western end gas collection system. Louisville Gas and Electric plant is in extreme left of picture. Southern tract of landfill is heavily wooded as evidenced by picture

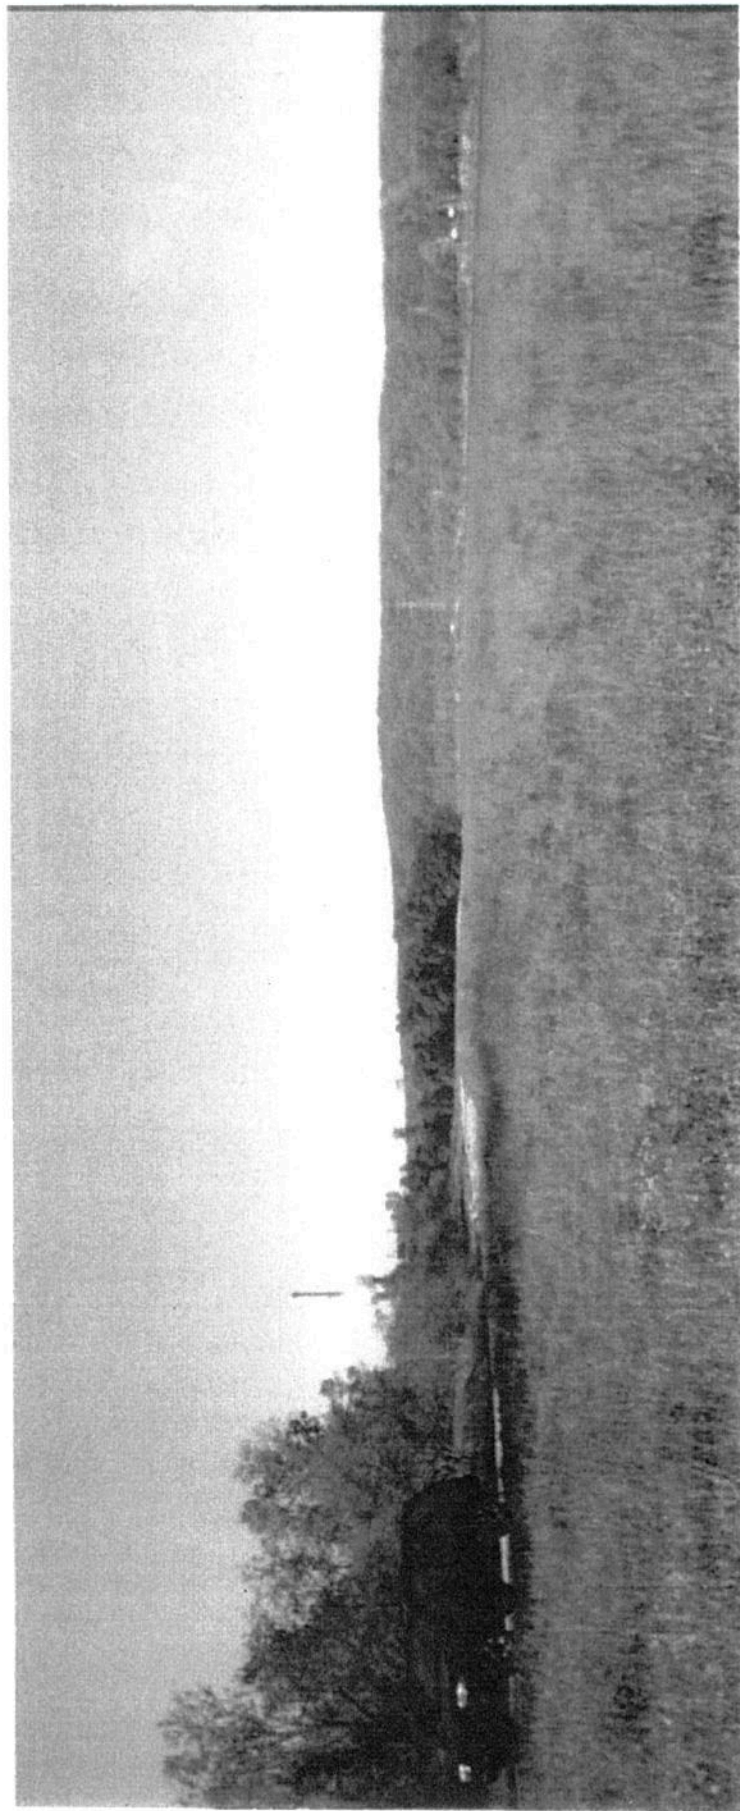
Photograph 6: Southwestern view of landfill cap area at the northern end of the central tract. Entire cap area is covered by the short grasses seen in picture. The Ohio River is shown along the central portion of the picture.

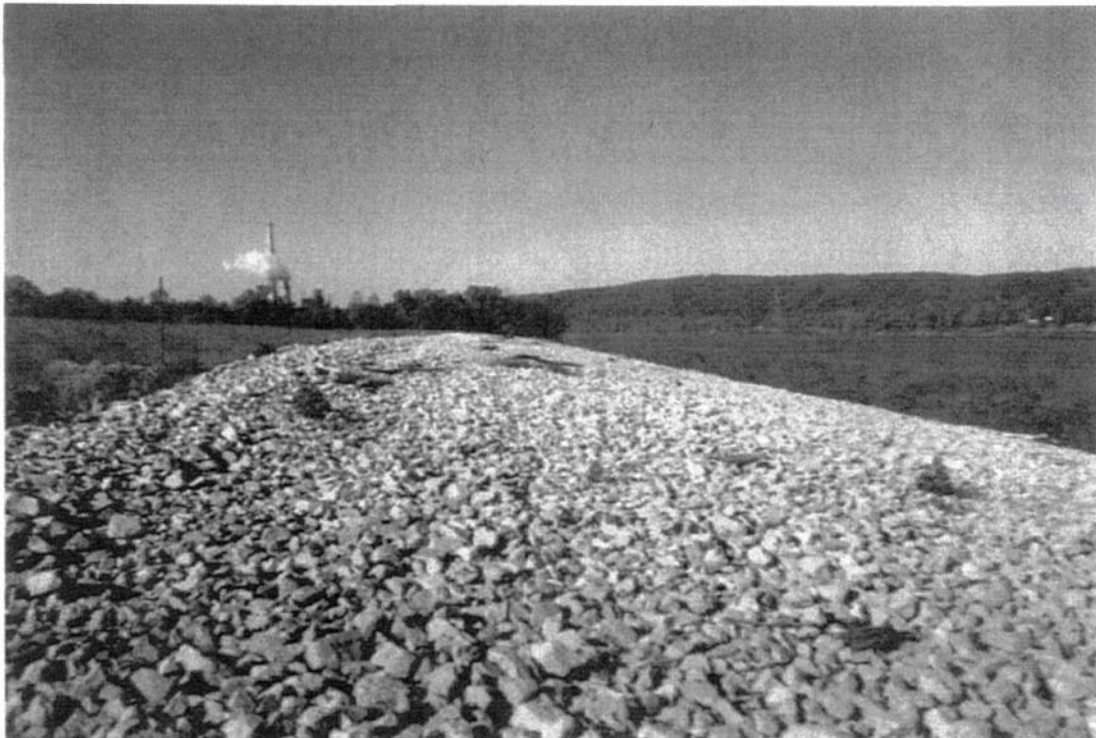
The rip rap-covered bank stabilization area appeared to be in good condition except for one area. Photographs 7, 8, and 9 illustrate the current conditions of this bank. The one exception is an area of channeling in the rip rap that may have occurred during flooding in the spring of 1997. The channeling only appears to have moved the rocks to different locations and did not erode into the cap material

Photograph 7: Southwestern view of riprap along bank stabilization area of landfill. This area is located along northern end of central tract of property. Debris, as a result of flooding, is scattered throughout riprap.

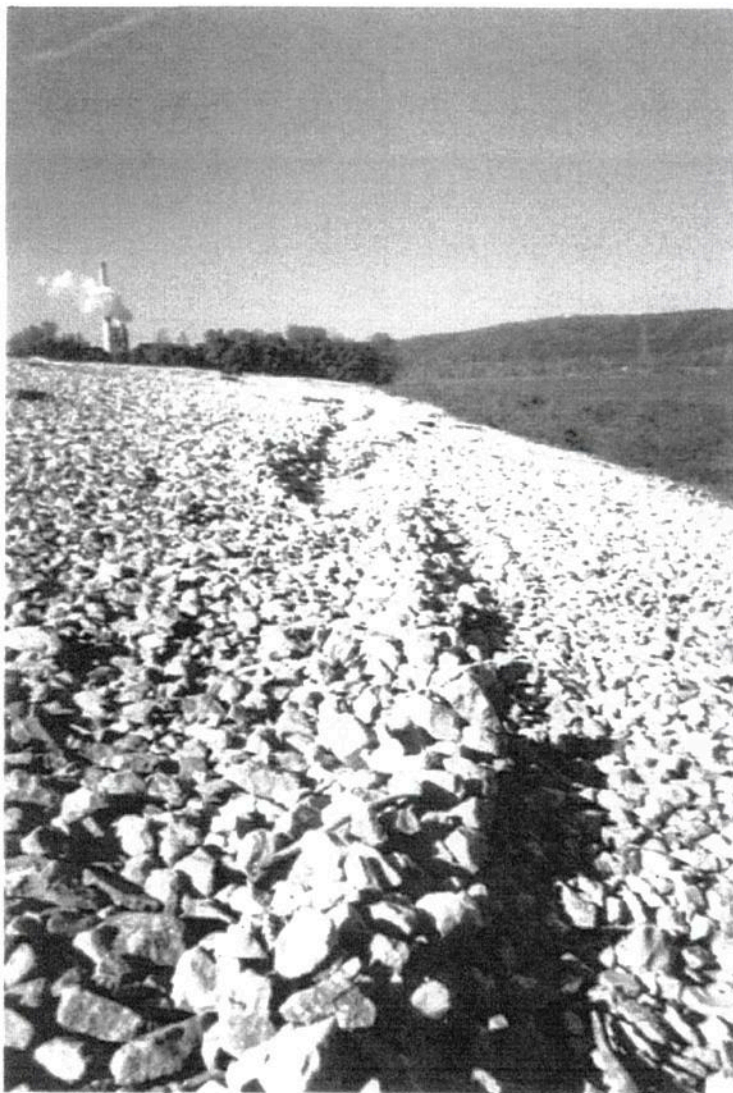
Photograph 8: Southwestern view of riprap, central portion of bank stabilization area. Note channeling that has formed within riprap as a result of recent flooding of Ohio River.

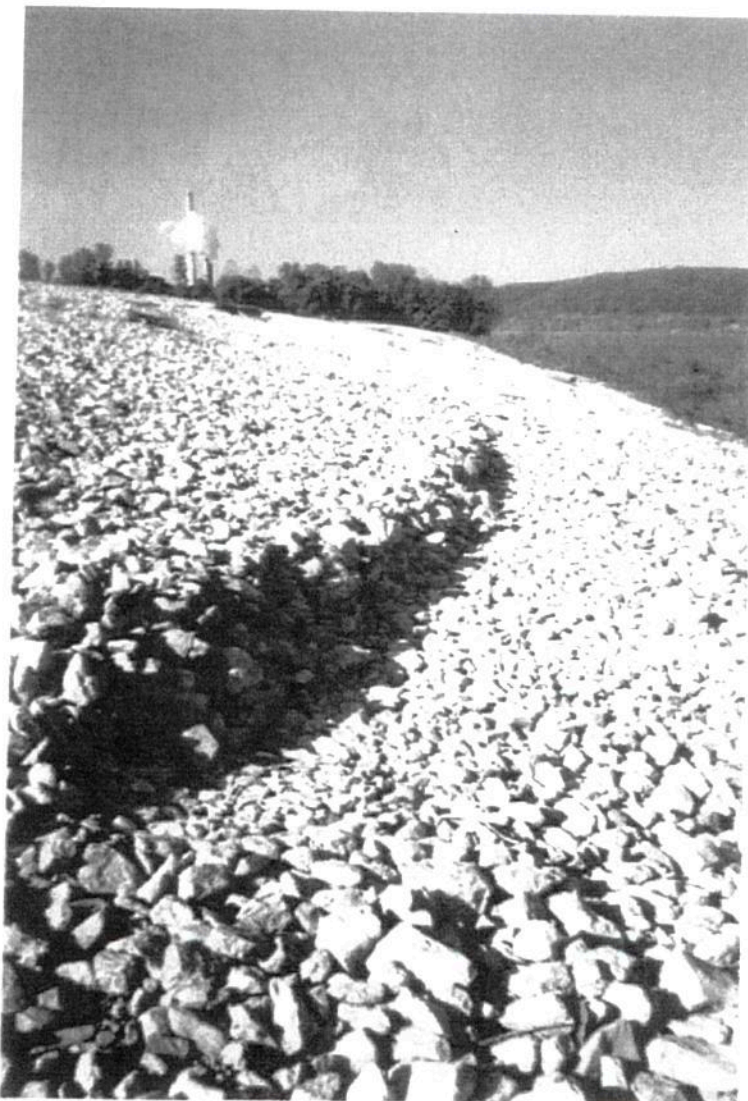
Photograph 9: Similar to photograph 8. The wall formed by channeling is approximately 2.5 feet high at the greatest height.

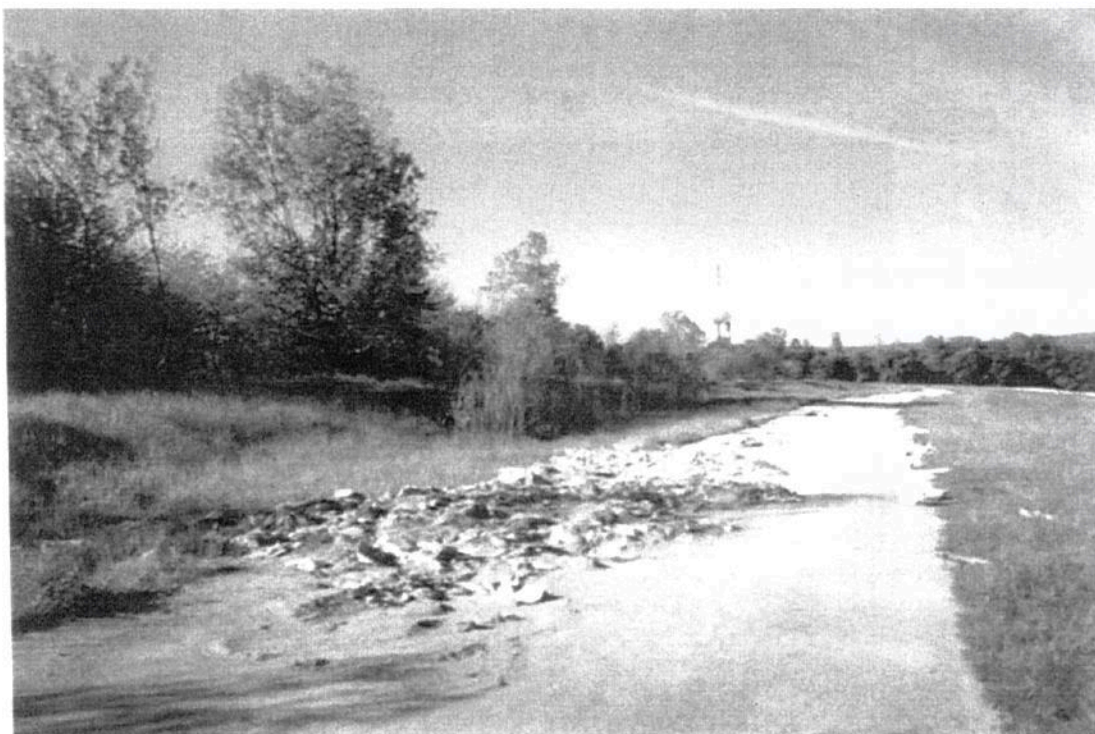
Photograph 10. Southwestern view of access road within the middle of the central tract of landfill. Sandbags in foreground were apparently used to fill a large depression that had formed in the roadway.

At the very least, monitoring of the areas of subsidence along the access road should continue on a quarterly basis. However, to decrease the chances of percolation of surface water into and through the buried waste, the larger areas of subsidence should be filled with appropriate low hydraulic conductivity materials to minimize stormwater infiltration. Also, the areas of subsidence should be backfilled where runoff will be directed away from the capped area to prevent ponding of water.

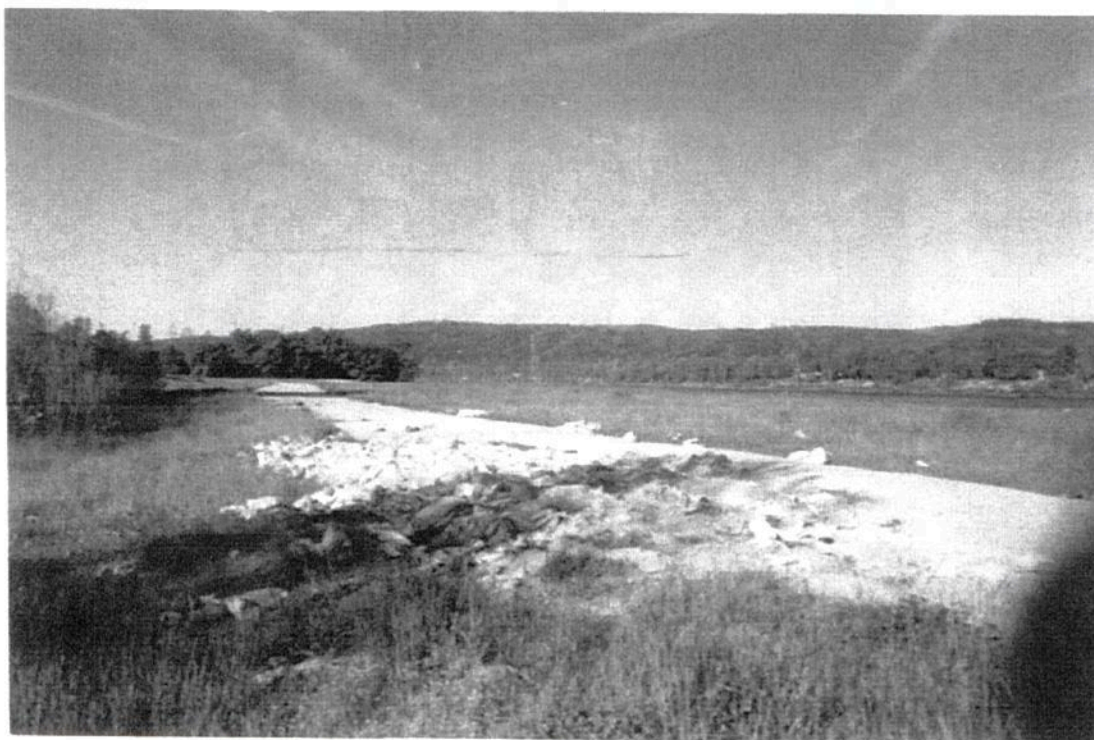
Photograph 11. Another view of sandbag filled depression in access road.

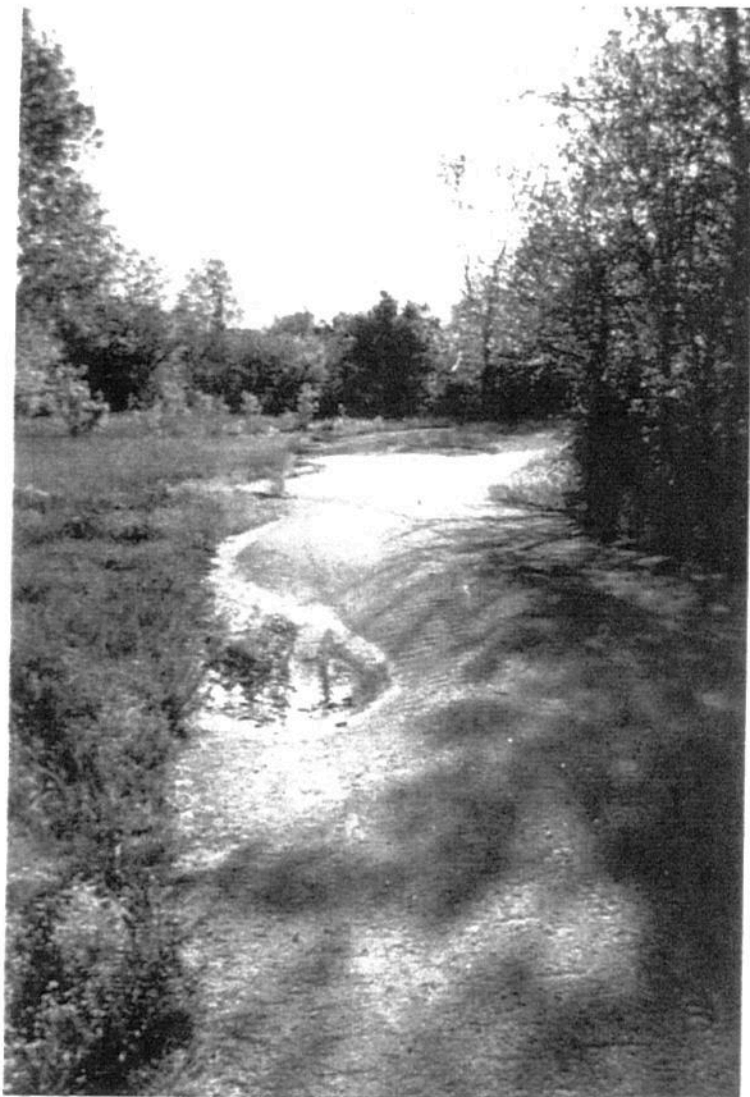
Photograph 12. Eastern view of depression in access road near former scalehouse location. This depression is located at head of riprap filled drainage channel located along eastern end of landfill cap area. The depression is approximately 10 feet long and 8 feet wide.

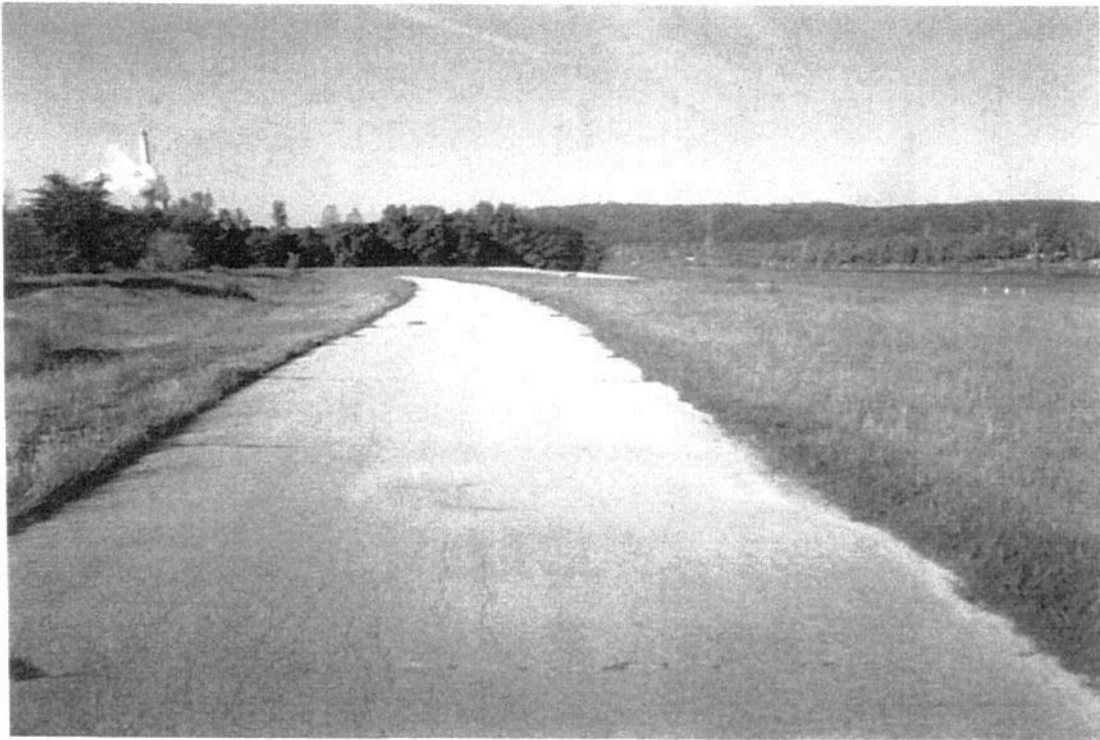
Photograph 13: Slight depression in access road. This depression is located within center of road in the central tract area. Depression is approximately 4 feet wide and 6 feet long.

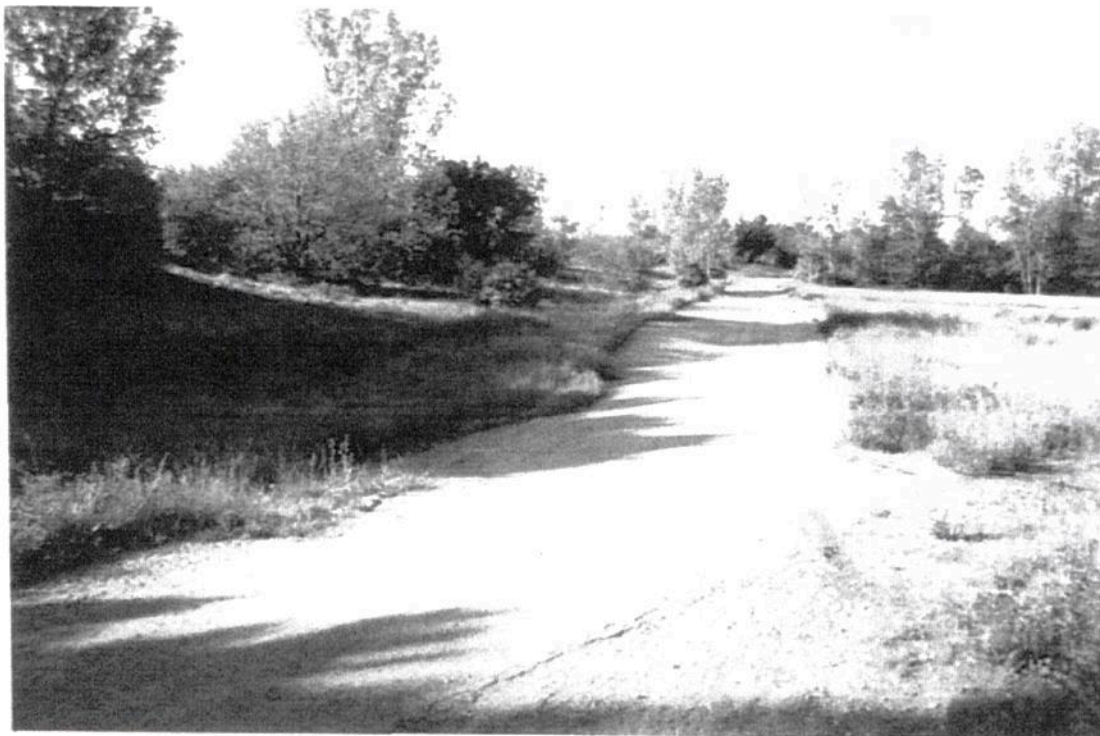
Photograph 14: This large depression has formed at the southern end of the drainage channel that crosses the landfill along the western end of the cap area. This depression has resulted in buckling of the pavement.

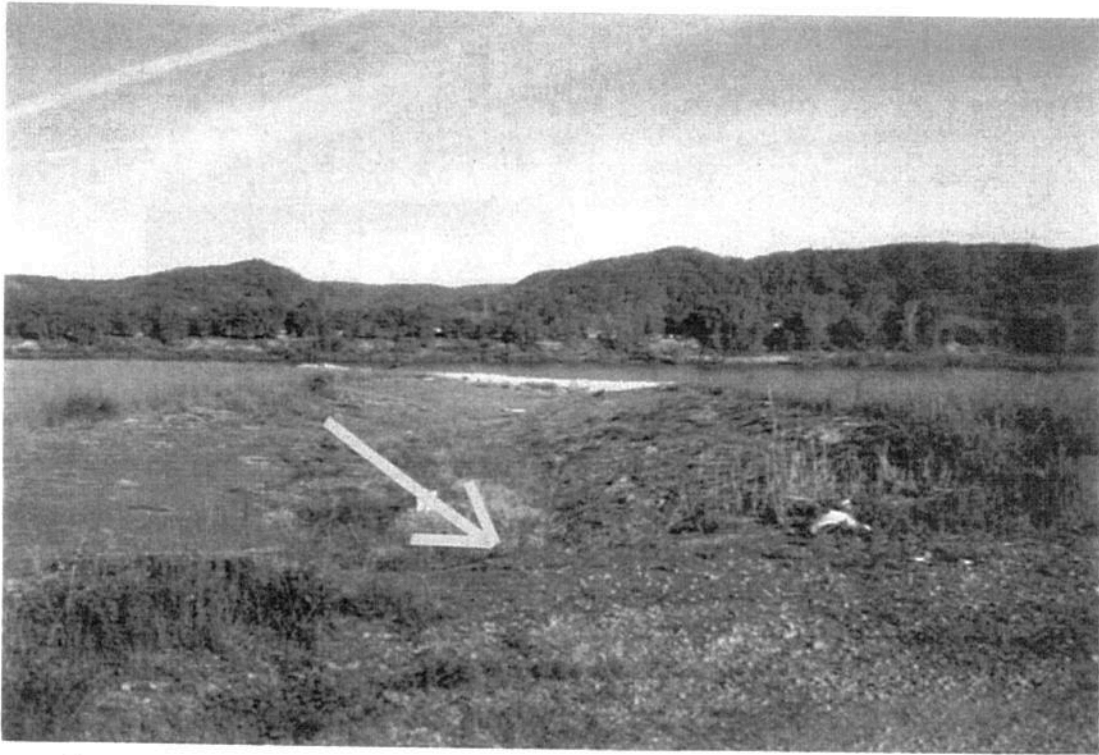
In the southwestern end of the cap area, a shale-lined drain is present. This drain is fed by a culvert running under the access road from the east. The western end of the pipe was partially visible, whereas the eastern end could not be found. Apparently, water on the eastern side of the access road is not traveling through the culvert and is either ponding or percolating into the underlying material.

Photograph 15: View of drainage channel crossing landfill at western end of capped area. Arrow points to northern outlet pipe that crosses under access road. Southern end of pipe could not be located.

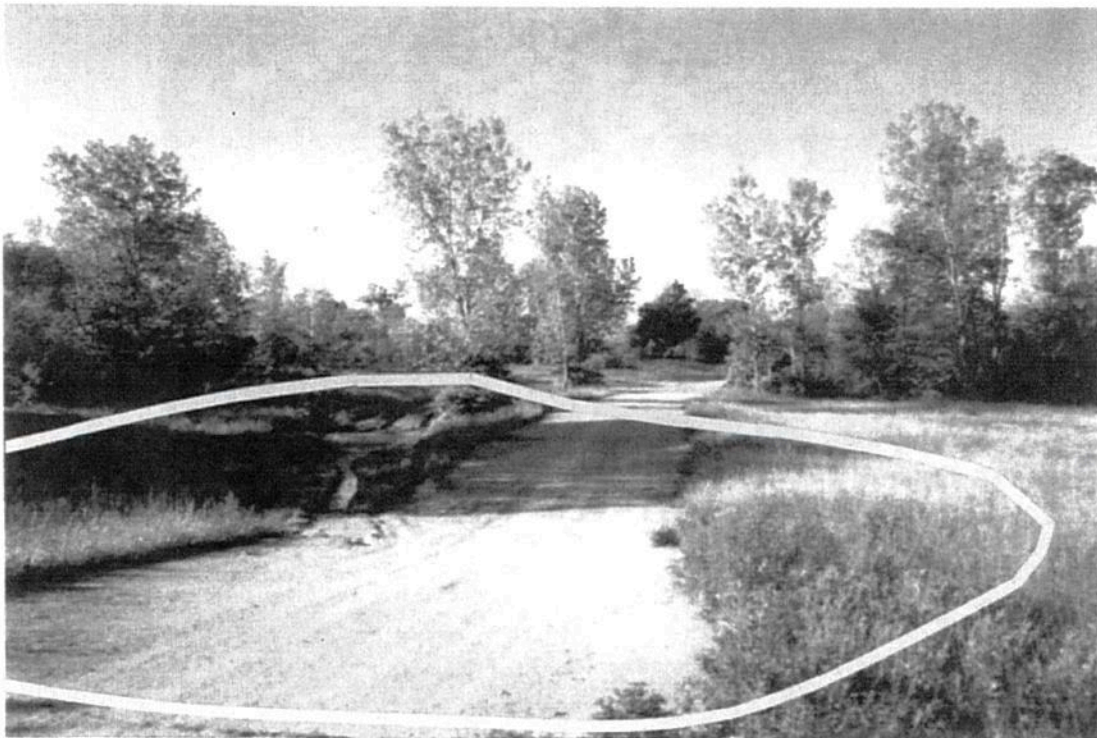
- Another large depression located at the southern end of the access road within the central tract. This area is associated with a buckling of the road. The depression has also allowed ATVs to travel off the roadway and through the standing water that has collected within this area. Several ATV trucks were observed to enter and exit through the standing water in this depression.

Photograph 16: Southwestern view of large depression along access road at western end of capped area. Yellow line demarcates edge of depression. Note standing water and automobile tracks leading into standing water. For scale, road is approximately 12 to 14 feet wide.

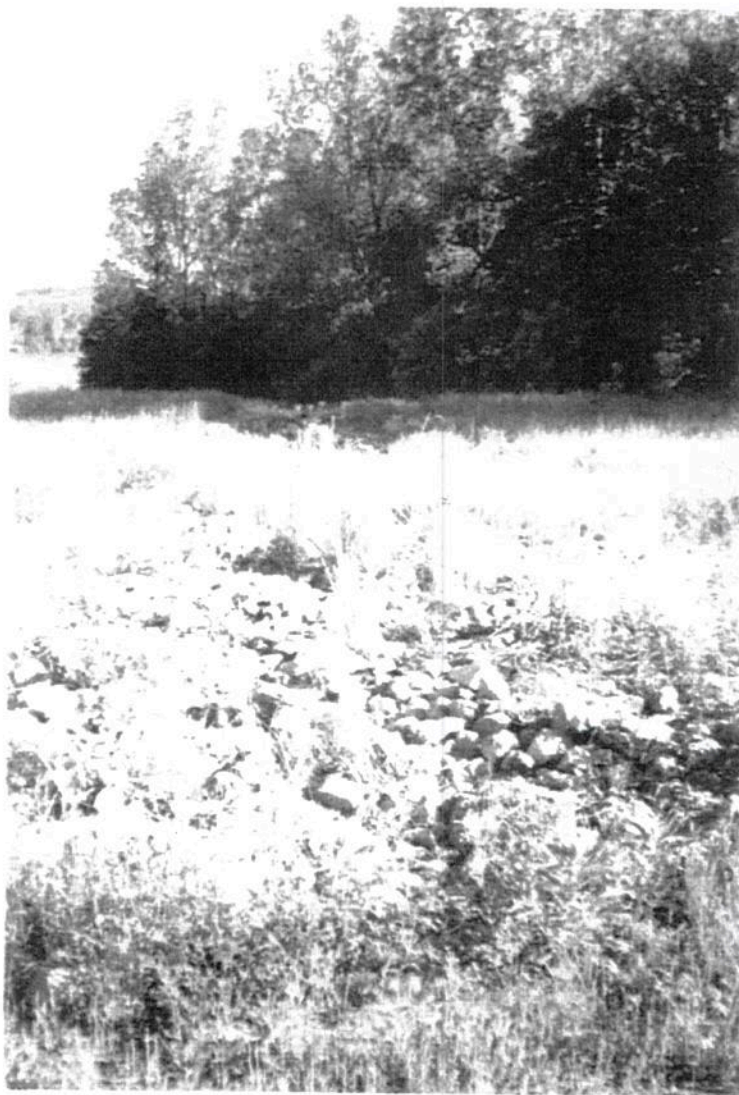
Photograph 17: Northern view of riprap lined drainage channel. The channel is located along the eastern perimeter of the capped area. The cap area is to the left in this picture. Note the significant amount of brush growth within the riprap. Also, brush growth becomes more significant towards the river.

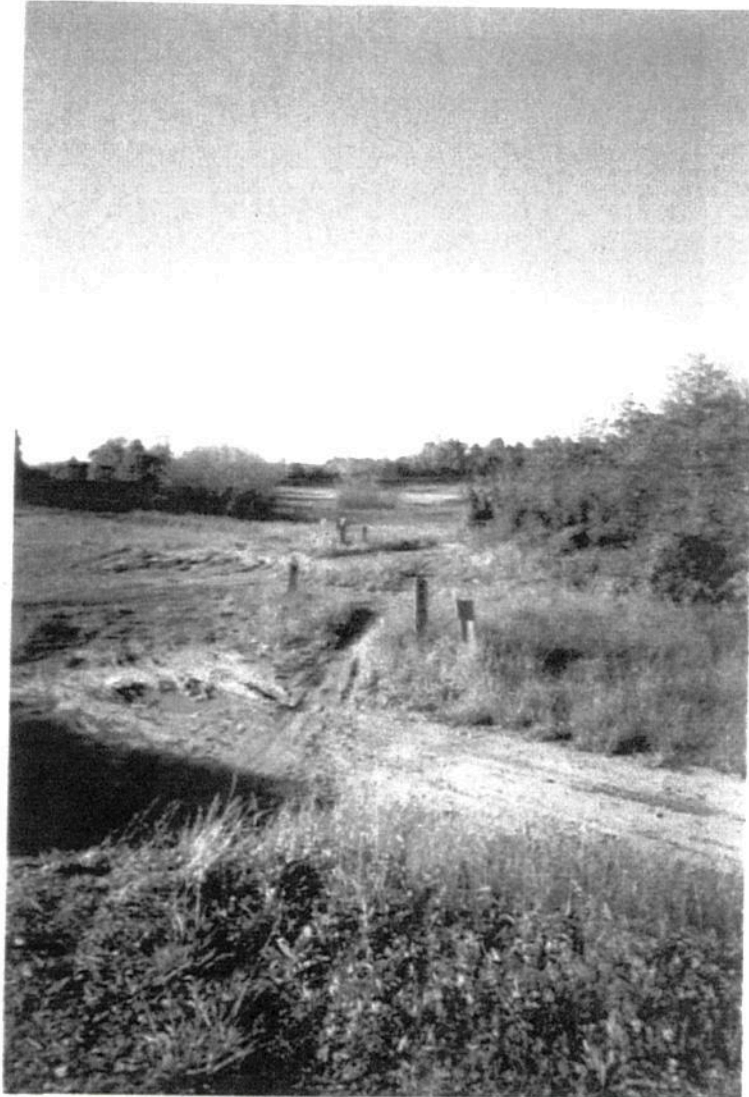
Photograph 18: Southwestern view of the western end of the gas collection system. Orange colored posts are barriers around the gas sampling points. Note the ATV tracks around the two barriers in the foreground.

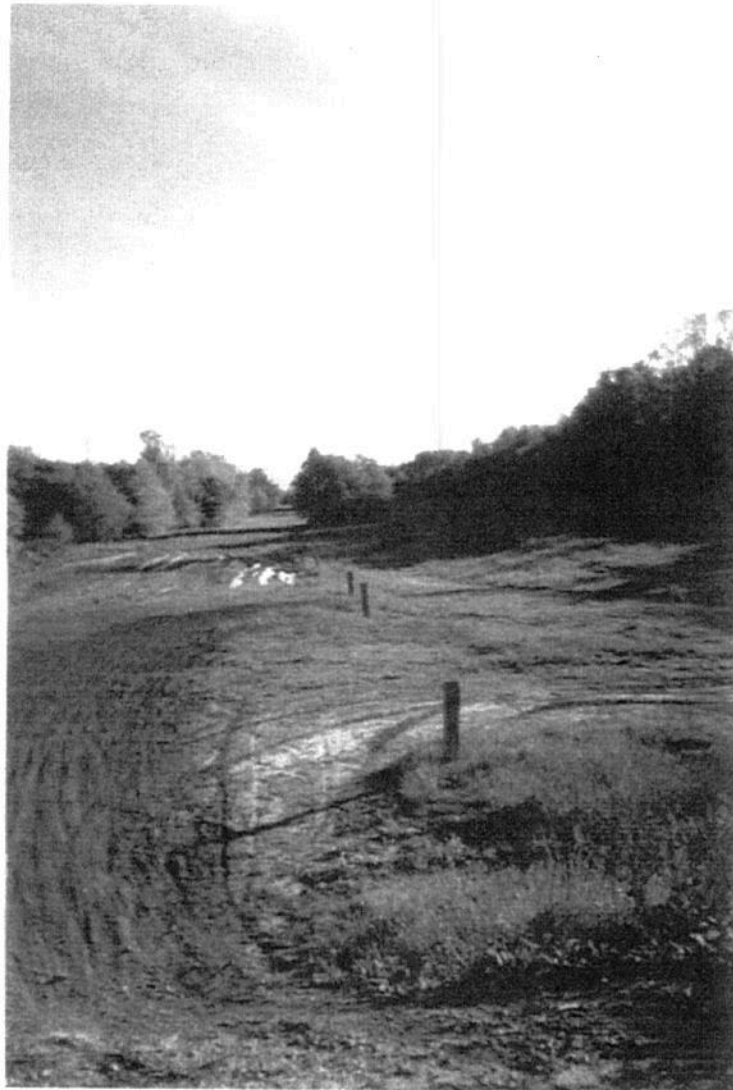
Photograph 19. Northeastern view of central portion of gas collection system. Orange colored posts are barriers adjacent to gas sampling points. Note the ATV tracks and areas of standing water around the barriers from the location of the photographer to approximately 200 feet away. Blower house is barely visible in left center of photograph.

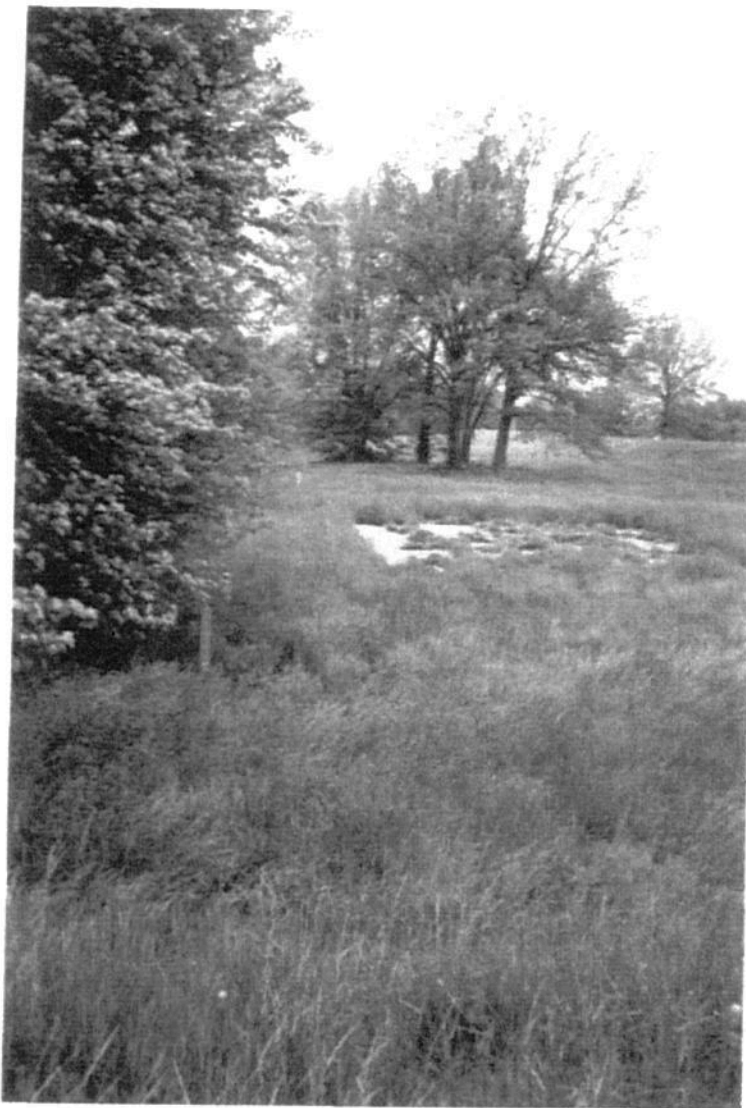
Photograph 20: Eastern end of gas collection system. Orange colored posts are barriers adjacent to gas sampling points. According to site documentation, this portion of the gas collection system is inoperable.

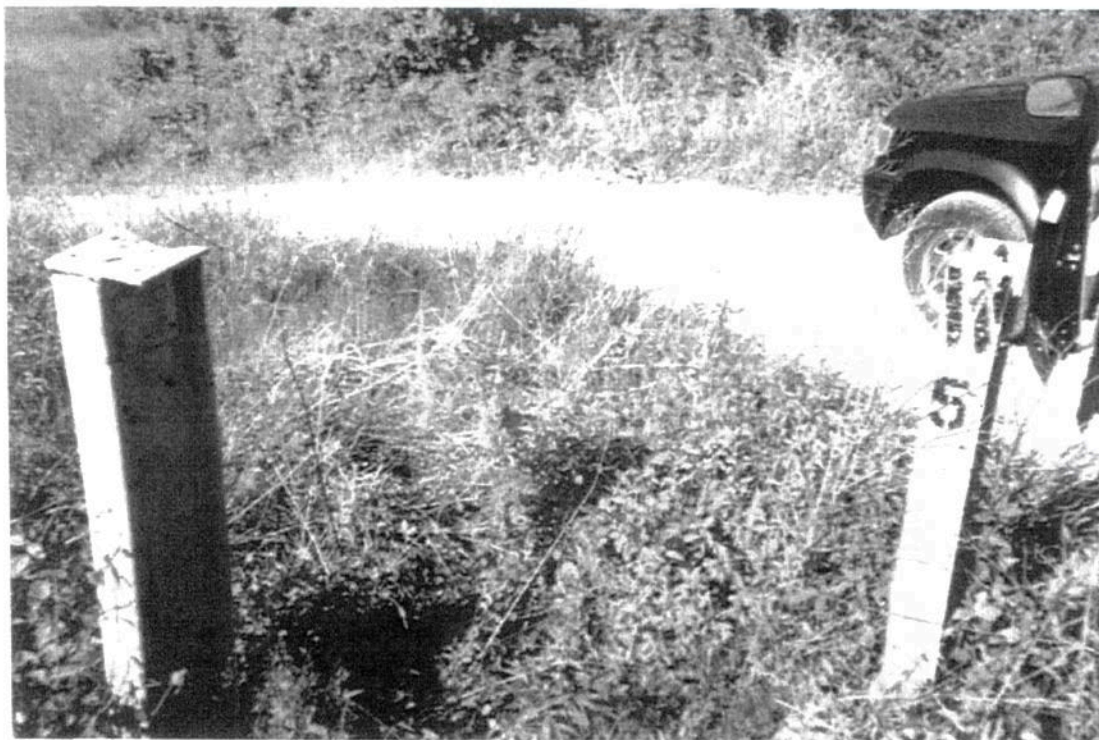
A review of the gas collection lines revealed that all of the gas recovery wells were clearly marked; however, locating the surface expression of the wells was difficult in many cases because of excessive plant growth around the surface completion (Photographs 21 and 22). Although the blower house appeared to be operating, no hissing or suction noises were heard along either end of the collection lines. Many of the concrete collars of the gas recovery wells were turned, tilted, or broken.

Photograph 21. Close-up view of gas sampling W5 at western end of gas collection system line. Note heavy growth of brush around location and ATV track in background. Gas sampling point lid could not be located in brush.

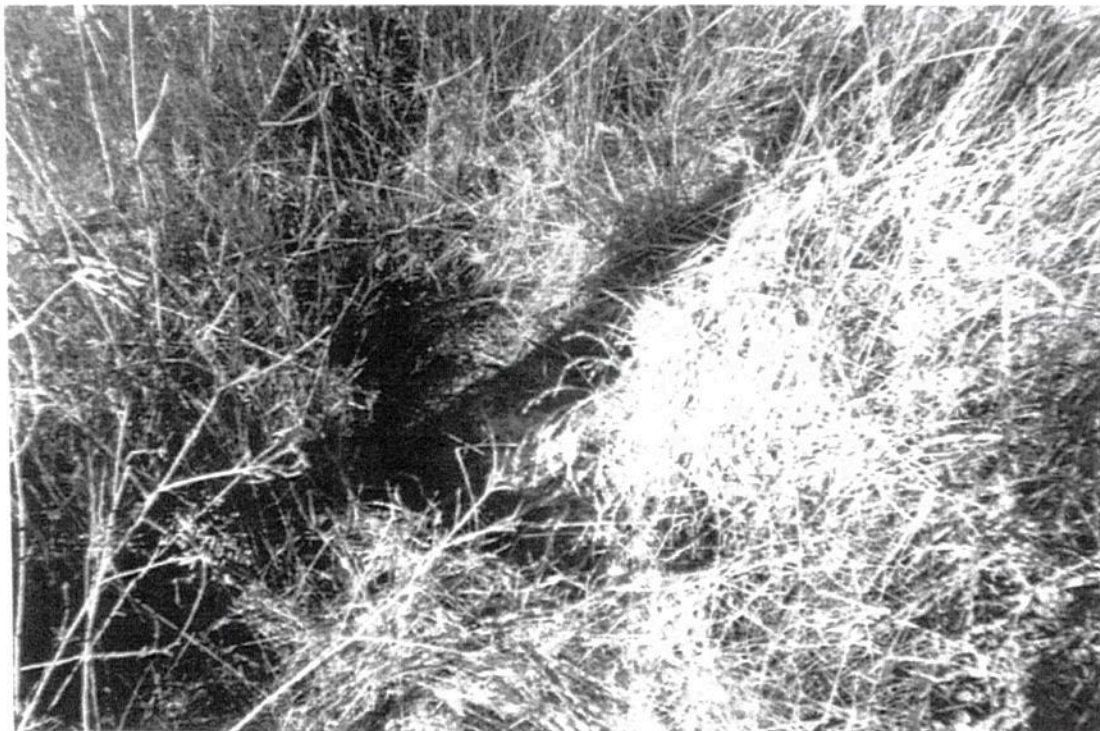
Photograph 22. Close-up view of lid of gas sampling point along gas collection system. Note the heavy growth of brush around unit. This same situation was encountered at all gas sampling points along gas collection system line.

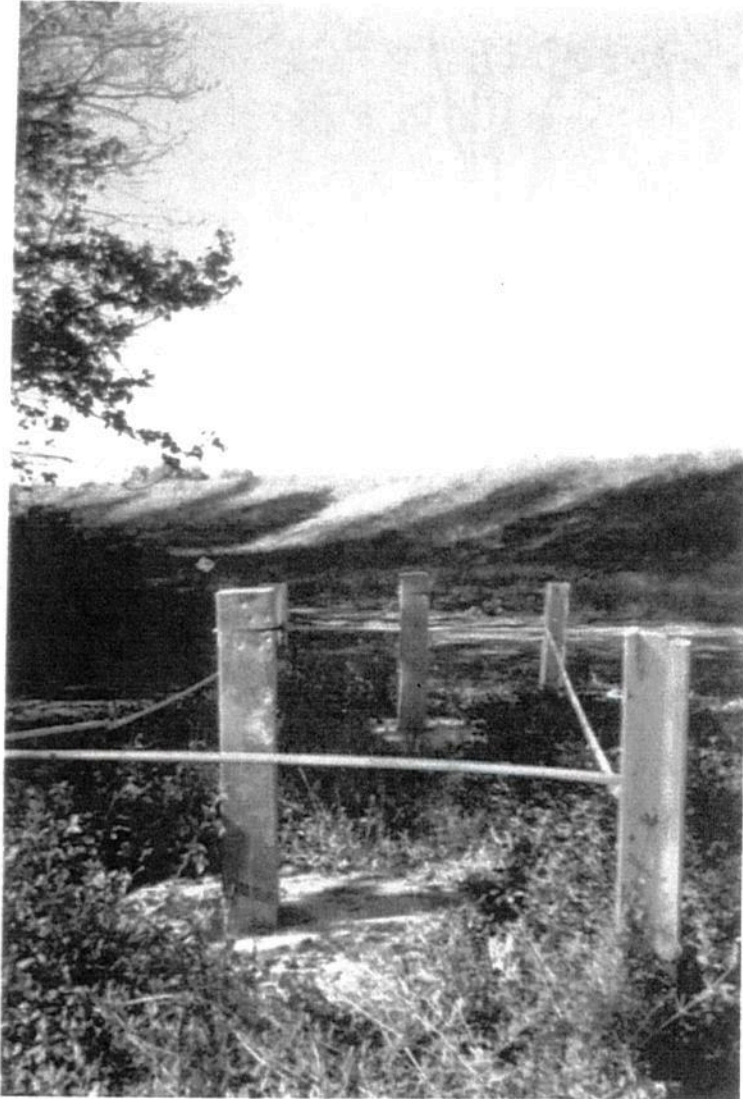
Well No.	Well(s) Locked?	Protective Casing Intact?	Pad(s) Condition	Barrier In Place?	Comments
G-1	Yes	Yes	Good	Yes	Dents in protective casings from bullets.
G-2	Yes	Yes	Good	Yes	Dents in protective casings from bullets.
G-3	Yes	Yes	Good	Yes	Dents in protective casings from bullets.
G-4	Yes	Yes	Good	Yes	Dents in protective casings from bullets.
G-5	Yes	Yes	Good	Yes	Fence cage around G-5 location; gate to cage unlocked; many weeds in and on cage.

Photograph 23: Gas wells G-1. Eastern view. Both protective casings locked. Both casings dented by bullets. Pads in good shape. This same situation was encountered at gas wells G-2, G-3, G-4, and G-5.
